Cape Hatteras at Buxton

Long-Term Average Annual Shoreline Change Study & Setback Factors

Updated Through 1998

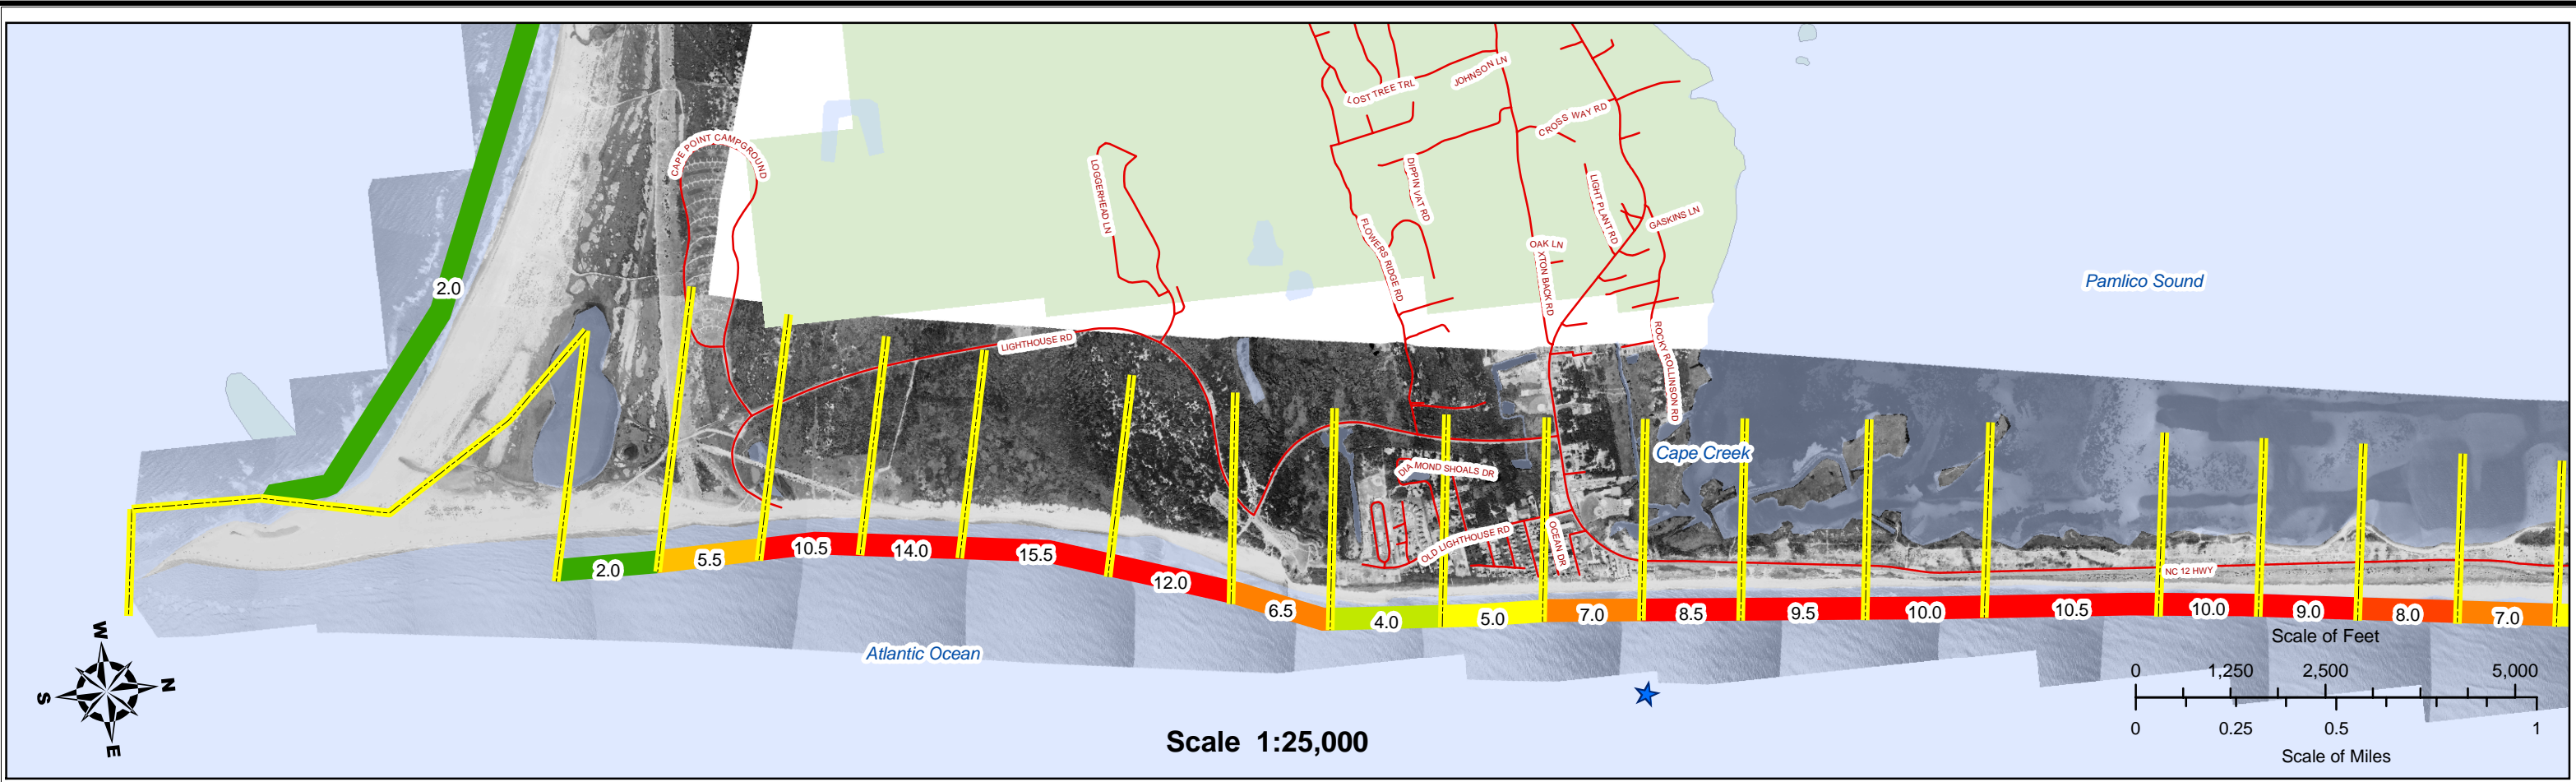
This map is for general information only. The map illustrates average rates of shoreline change over approximately 50 years. The information presented here is not predictive nor does it reflect the short-term erosion that occurs during storms. This map may not be suitable for property-specific determination of erosion rate factors due to its small scale. For a site-specific determination contact your CAMA Local Permit Officer or the regional field office of the North Carolina Division of Coastal Management.

2.0 → "2.0" Indicates a 1998 Setback (Erosion) Factor of 2.0 Feet / Year

★ This general area has been influenced by beach nourishment either for beach protection or dredge disposal. This action artificially lowers the erosion rate in this area.
